CONNECTICUT RIVER BASIN
WESTBROOK, CONNECTICUT

**MESSERSCHMIDT POND DAM
CT 00392**

**PHASE I INSPECTION REPORT
NATIONAL DAM INSPECTION PROGRAM**

NOVEMBER, 1979

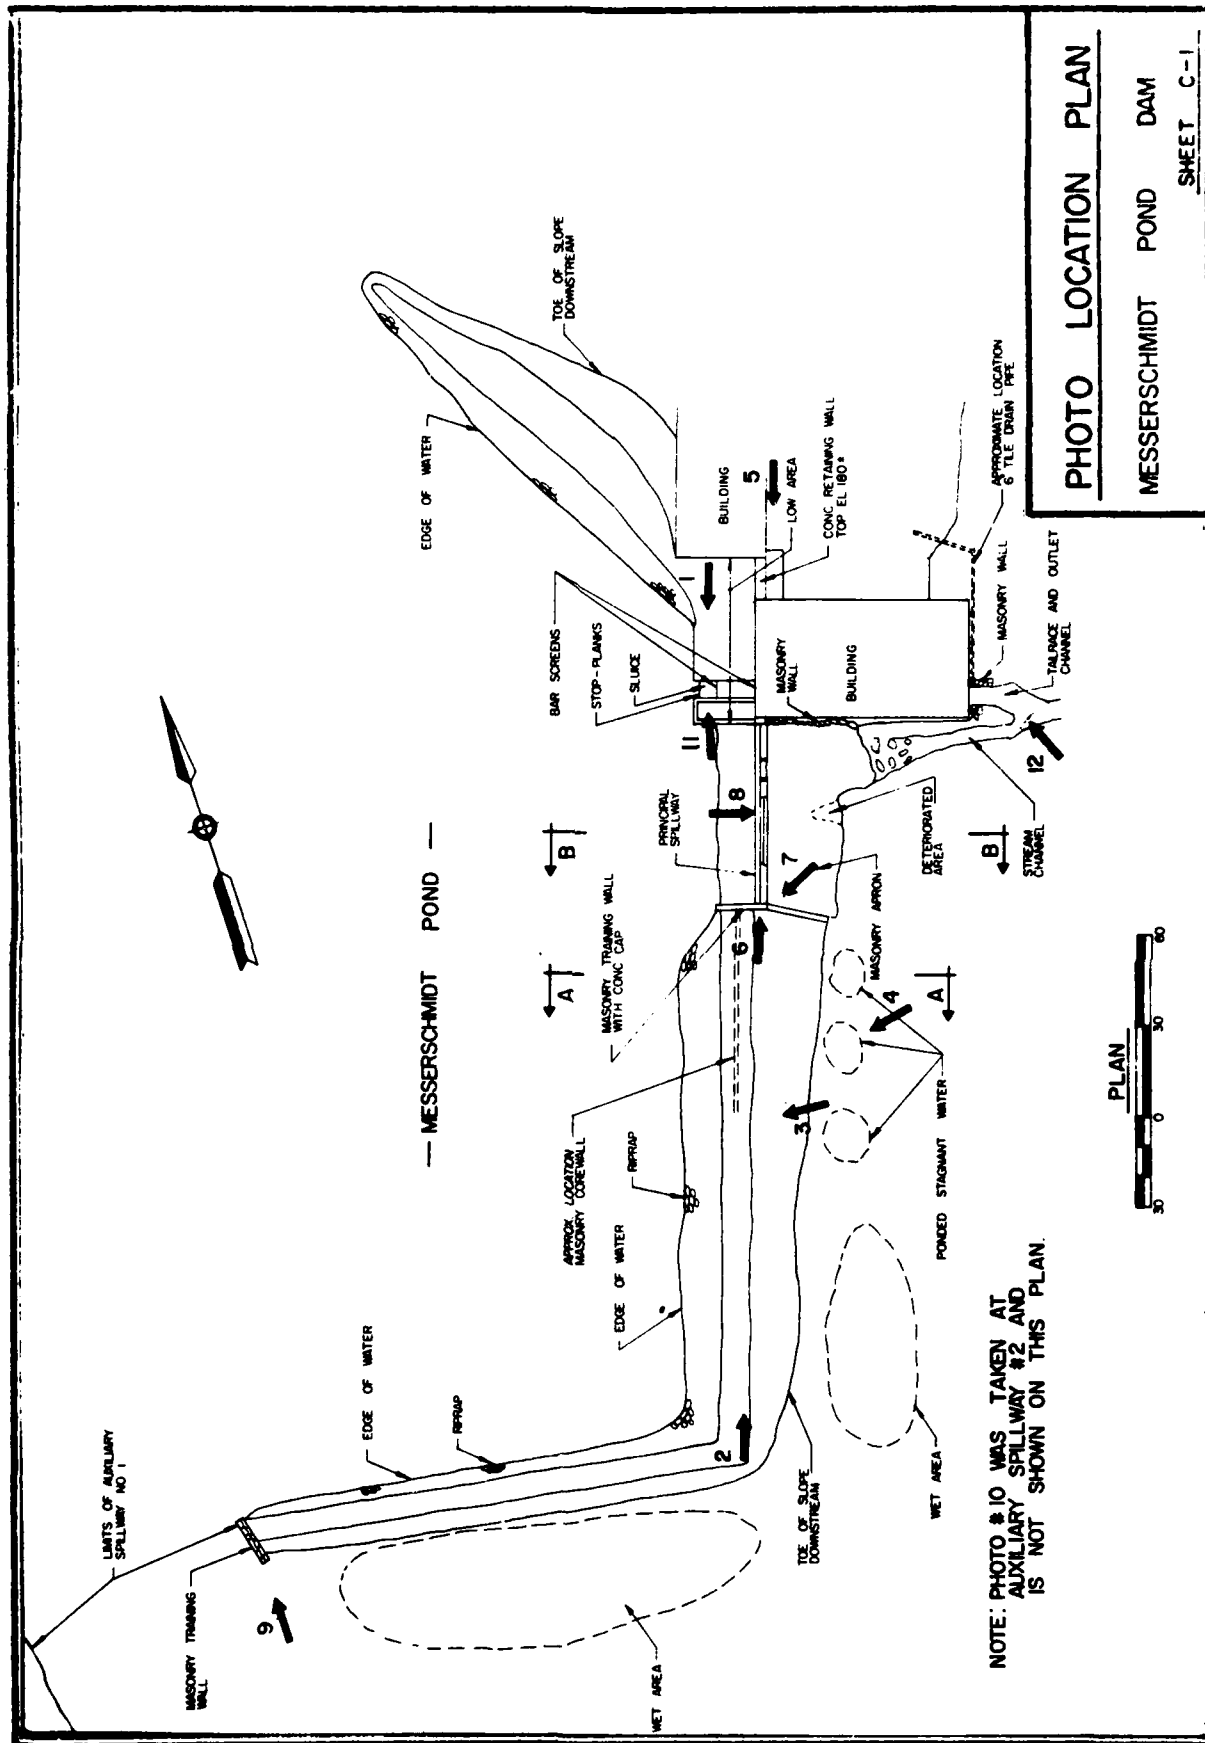
MESSERSCHMIDT POND DAM
SHEET C-1

PHOTO LOCATION PLAN

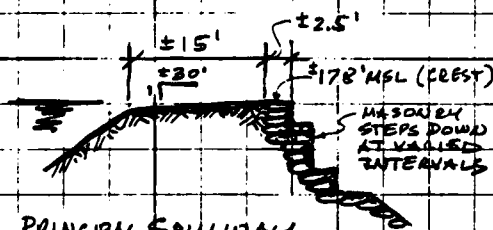
PRINCIPAL SPILLWAY

THE PRINCIPAL SPILLWAY, TO THE RIGHT OF THE FACTORY BUILDING IS A STONE MASONRY BROAD CRESTED WEIR (±) 63' LONG WITH SLUICING UP FACE AND VERTICAL (STEPPED) D/S FACE. (SEE SKETCH). THE BREADTH OF THE CREST IS (±) 2.5'. THE HEIGHT OF THE RIGHT SIDE WALL (STONE
